# **Inspection of Tail Boom/Fenestron Junction Frame on EC130 B4 Eurocopter Aircraft Using Phased Array**

## **Abstract**

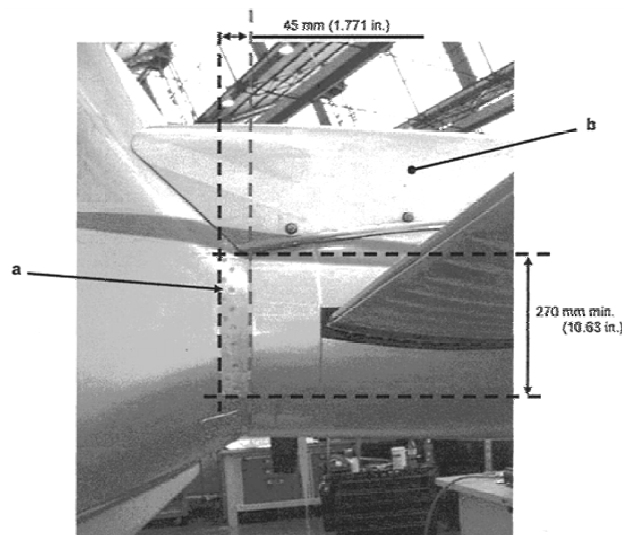
The compliance to the AD requires stripping the paint from the area on the outside of the frame as shown below at position a. The paint stripping ensures that all rivet heads are made visible to the naked eye.

Figure 1: Paint strip area at the tail boom / fenestron junction frame

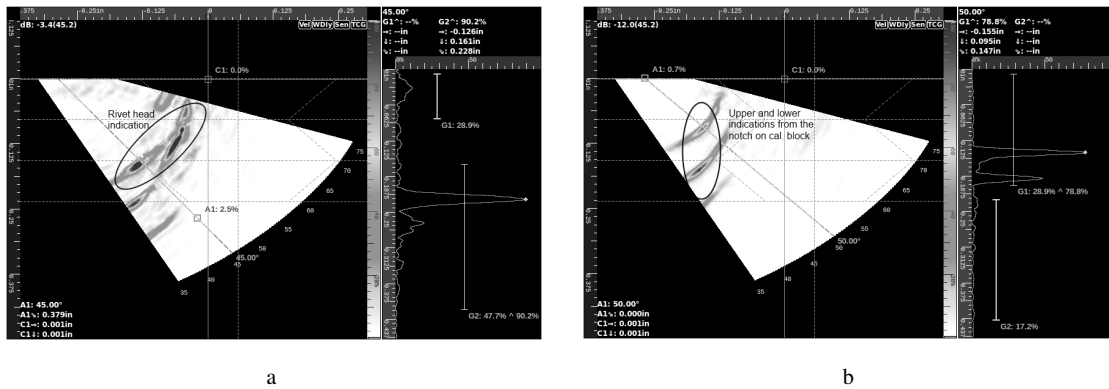
Prior submitting the exact details of the proposed changed, preliminary tests have been conducted on a first aircraft to evaluate the feasibility of using ultrasonic phased array for the detection of cracks at the tail boom/fenestron junction frame. It has been clearly validated that indications from fastener holes could be properly detected. Each fastener returned a loud echo with a distinctive ultrasonic signature. It was then confirmed that the complete area of interest could be inspected using a small foot print and high frequency transducer. As it can be seen on Figure 1, a small foot print was required due to the curved shape of this critical region. The next step consisted in preparing samples of the same material and thickness with identical fastener holes. Notches have been added with their initiating point at the edge of the fasteners holes. Different paint thicknesses have been applied to monitor the effect of the paint on crack-like indications. The material being tested had a nominal thickness of 70 mil (1,78mm) and the maximum paint layer was 25 mil (0,63mm). An attenuation of up to 6dB has been measured on the calibration sample for the thickest layer of paint. Figure 2 shows a typical echo from a fastener with no cracks.

The inspection is carried using a sectorial scan with a high gain sensitivity. The first goal is to ensure crack detection. If there is presence of a crack, then the location and length of the crack will dictate the action to be taken.

Figure 2: Example of a rivet head indication with no crack (a) and indication from a notch (crack-like indication) (b)
