Introduction

Issue

Following a requirement from a global producer of aluminium to carry out volumetric ultrasonic inspections to their conveyor belts that were nearing its design life Sonatest Ltd were asked to support validation trials to ascertain accurate remaining wall thickness of the belt and condition of the internal galvanised steel cords.

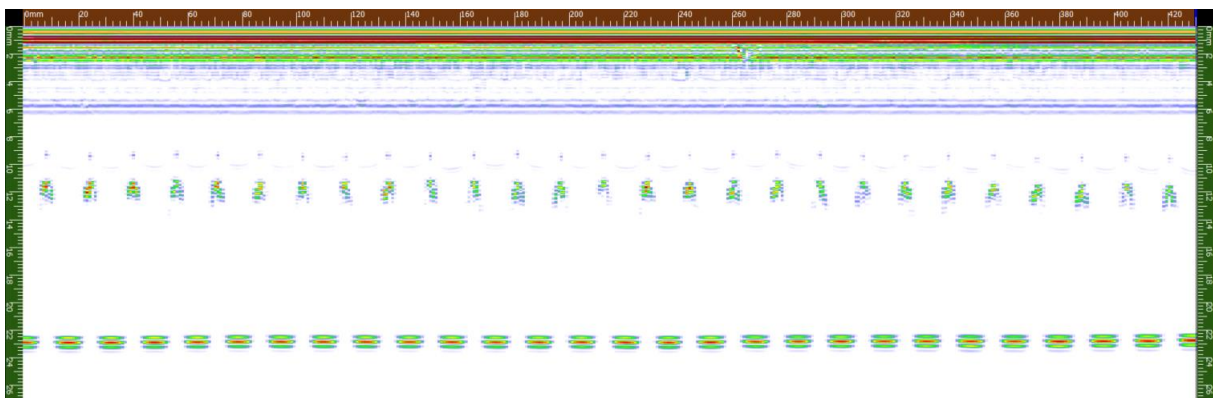
Figure 3 – B-Scan showing the backwall and reinforcement cords

The scan showed the internal cords and the back wall of the belt clearly. (see figs 3-5)

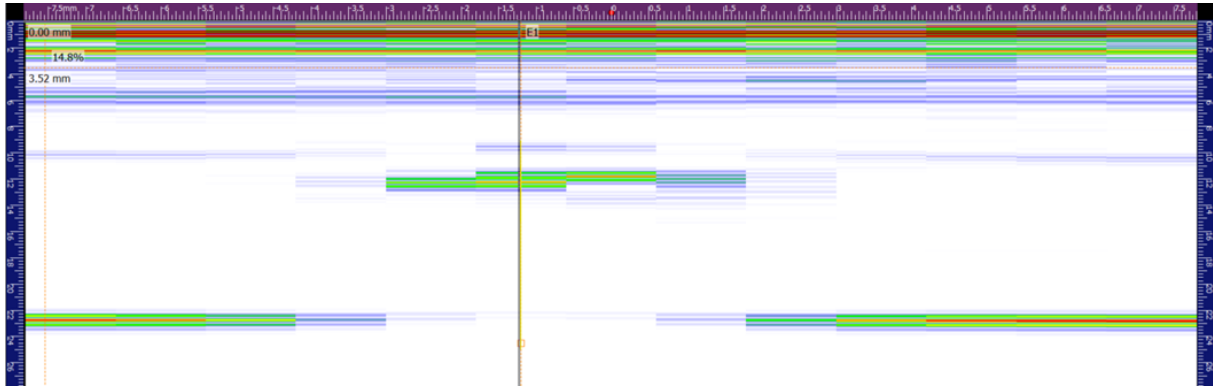
Figure 4 – L-Scan showing the backwall and reinforcement cords

An encoded phased array L-Scan was used to scan a 10mm wide x 500mm length of the belt.

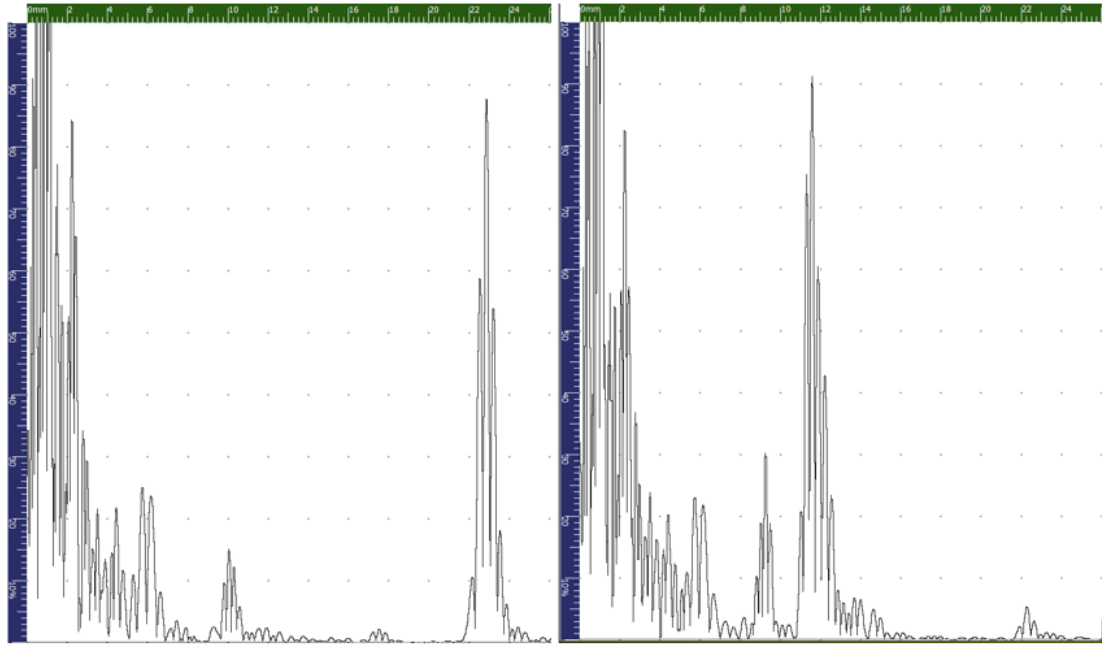
Figure 5 – A-scans showing the response from the backwall (left) and a reinforcement cord (right)
