Introduction

This application note highlights the use of phased array ultrasonics to reliably perform the bolt hole inspection in a repeatable and more time efficient manner. Phased array also offers additional ways to view the data allowing for quicker defect identification and more accurate sizing.

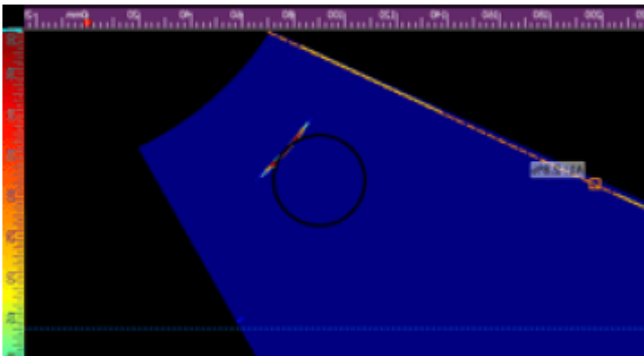
Figure 3 – ½ skip inspection, Left image shows a bolt hole with no defects, Right image shows a bolt hole with cracking on both sides

The four images above show the bolt hole with and without defects,

Figure 3 – Left image shows the response going direct onto the bolt hole, this produces one reflection from the hole. Figure 3 Right image shows the same direct scan, this time hitting 3 or 4 defects around the hole, it is possible to differentiate the top response as a defect rather than geometry because its two separate reflections close together.

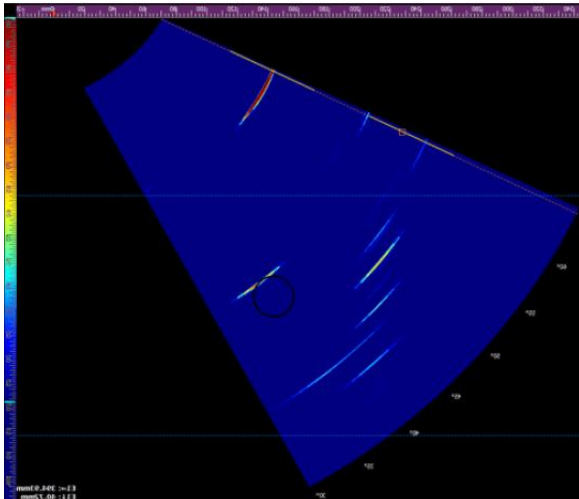
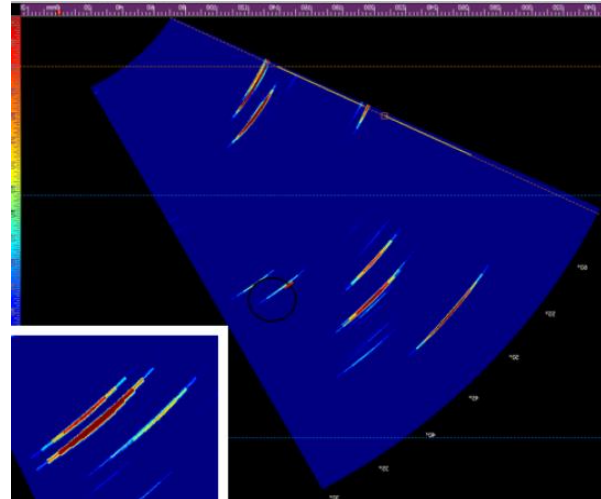
Figure 4 – full skip inspection, Left image shows a bolt hole with no defects, Right image shows a bolt hole with multiple cracks.

Figure 4 shows the scan images of the bottom side of the bolt hole, this time skipping is needed as shown in Figure 2, when the sound is reflected up from the bottom of the track in order to get full coverage. Figure 4 Left image shows the response with no defect, whereas figure 4 Right image shows the hole with two defects, the zoomed in image shows the two reflections from the right hand signal.
